# Belzona Repairs Pump Mouth

Industry: Water / Wastewater  
Application: CEP-Centrifugal Pumps  
Substrate: Steel  
Products: \* Belzona 1311 (Ceramic R Metal) ,  
\* Belzona 1321 (Ceramic S Metal) ,  
\* Belzona 5821 ,

Customer Location: Northern Germany  
Application Date: 2022

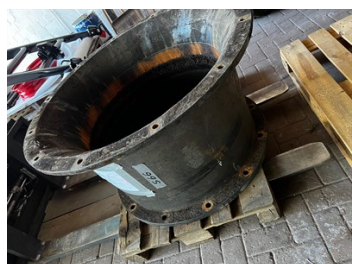
Heavy corrosion in the area where the propeller runs.

- \* Image 1: Pump Mouth to Repair ,
- \* Image 2: Close up heavy corrosion ,
- \* Image 3: Belzona Products Applied ,
- \* Image 4: Complete Application ,

Waste Water Pump has suffered heavy corrosion during operation and is need of repair a replacement would cost the client 11.000 EUROS.

After blasting in accordance with Belzona standards the corroded areas were filled with Belzona 1311 and then coated the complete inside with two layers of Belzona 1321. The upper part we overcoated and then the external coating was coated with Belzona 5821. Please refer to Belzona systems leaflets CEP-03 & CEP-05 for further details of products that can be used for this type of application.
