Belzona Repairs Pump Mouth

ID: 8797

Industry: Water / Wastewater
Application: CEP-Centrifugal Pumps
Substrate: Steel
Products: * Belzona 1311 (Ceramic R Metal) ,
* Belzona 1321 (Ceramic S Metal) ,
* Belzona 5821 ,

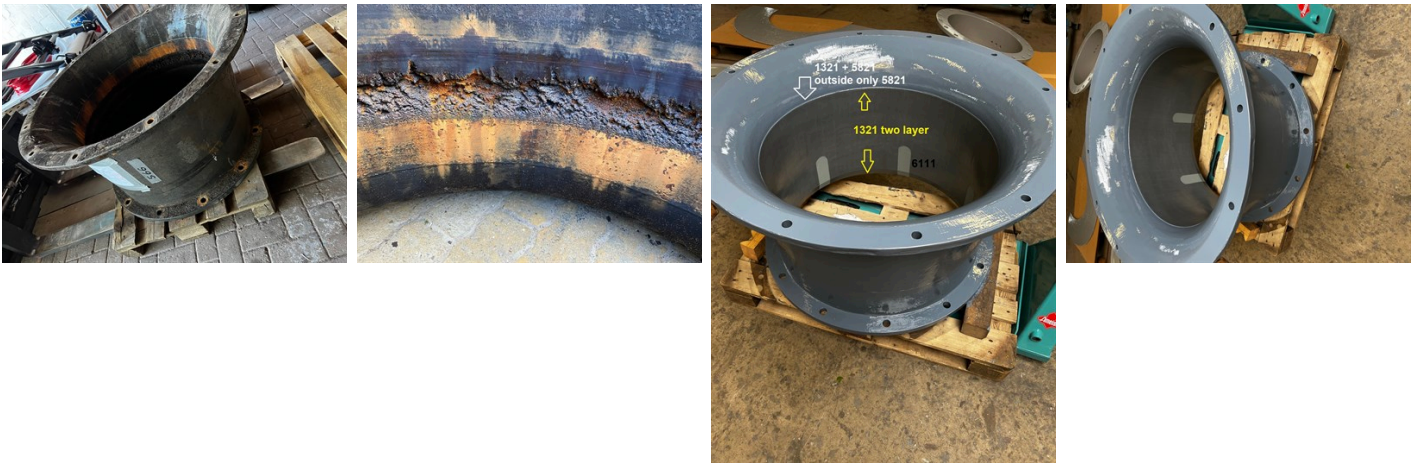
Heavy corrosion in the area where the propeller runs.

- * Image 1: Pump Mouth to Repair ,
- * Image 2: Close up heavy corrosion ,
- * Image 3: Belzona Products Applied ,
- * Image 4: Complete Application ,

Waste Water Pump has suffered heavy corrosion during operation and is need of repair a replacement would cost the client 11.000 EUROS.

After blasting in accordance with Belzona standards the corroded areas were filled with Belzona 1311 and then coated the complete inside with two layers of Belzona 1321. The upper part we overcoated and then the external coating was coated with Belzona 5821. Please refer to Belzona systems leaflets CEP-03 & CEP-05 for further details of products that can be used for this type of application.
