Pipe Repair at a Pump Station

ID: 8800

Industry: Water / Wastewater

Application: VPF-Valves, Pipes and Fittings

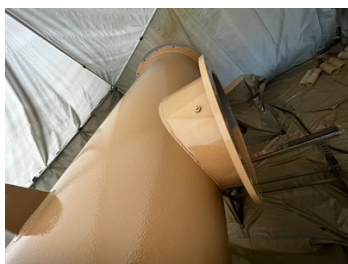
- * Image 1: First Layer of Belzona 5811 ,
- * Image 2: Second Layer of Belzona 5811 ,
- * Image 3: Internal Application Complete ,
- * Image 4: External Application Complete ,

The heavy corroded areas were filled and smoothed with Belzona 1111. Belzona 5811 was used to coat the internal and external of the pipe for further corrosion protection.
