# BELZONA REPAIRS AND PROTECTS MACHINE TOOL COOLANT TANK

ID: 884

**Customer Location:** Aerospace Component Manufacturer, KS  
**Application Date:** February 2007

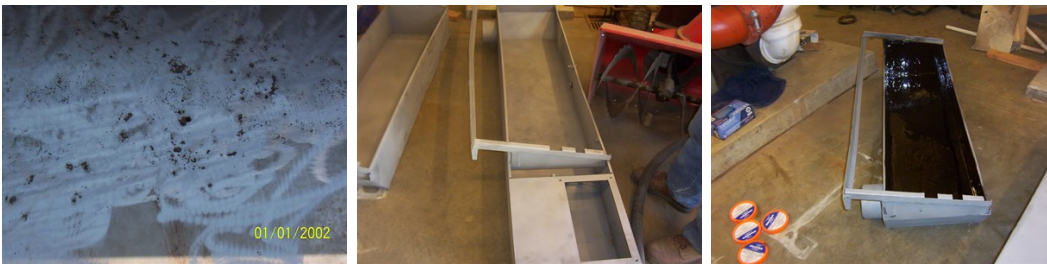
## Photograph Descriptions

The cutting fluid is water based. The tanks rust because the cutting fluid and the cuttings sit on the bottom of the tank. The tanks leak and cause a big mess and safety hazard.

- \* Typical rust holes ,
- \* Blast cleaned tank ,
- \* Totally sealed tank ,

Application was carried out in accordance with Belzona Know-How System Leaflet TCC-5.
