# Belzona Coated Ship Scrubber Pipes Revisited After Two Years In Service

Customer Location: RO – RO SHIP, TURKEY  
Application Date: August, 2020

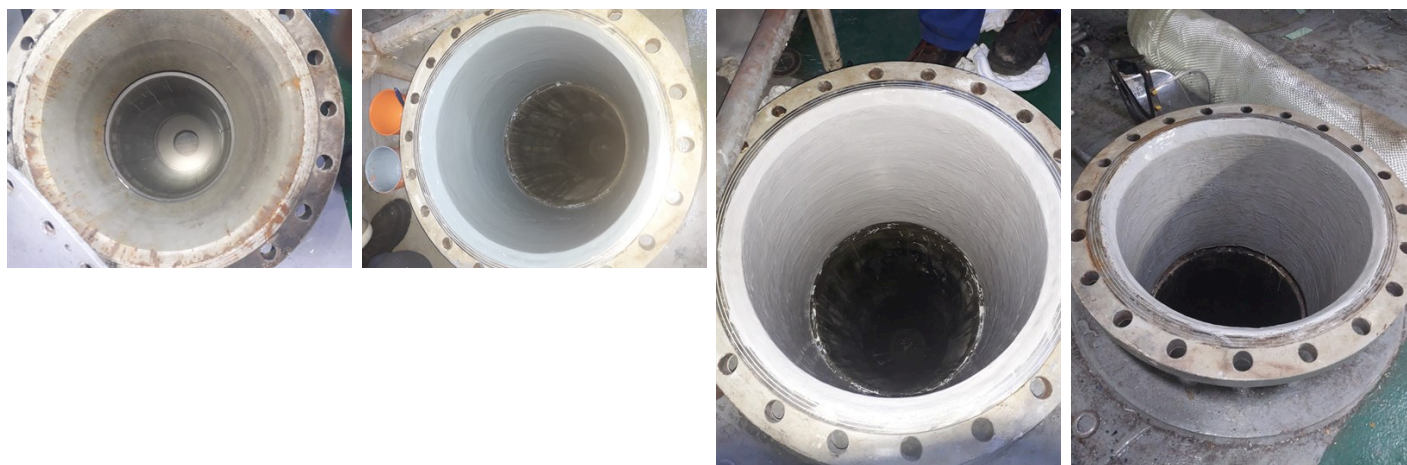
The corrosive and harsh environment of Exhaust Scrubber line fluid caused damage on internal steel pipe surfaces.

- \* 1. Scrubber pipe without any protective coating ,
- \* 2. After applied first coat of Belzona 1391T ,
- \* 3. After applied second coat of Belzona 1391T ,
- \* 4. Checked the condition of the pipes after 2 years of service ,

The application was carried out in accordance with Belzona System Leaflet VPF-02 and TCC-05. The surface was prepared and cleaned. Two layers of Belzona 1391T were applied to coat the internal surface of the steel pipe for protection against further corrosion and cavitation damage. After completion of the coating application, post cure has been applied according to the IFU.
