Belzona Repairs a Live Water Leak on a Refrigerant Suction Pump

ID: 8846

Industry: Sugar

Application: VPF-Valves, Pipes and Fittings

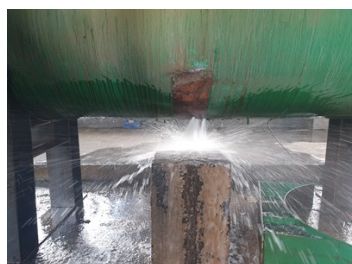
The pipeline connected to a suction pump on a closed circuit refrigeration system had suffered from bi-metallic corrosion (A.K.A galvanic corrosion) due to the pipe support, resulting in a complete loss of wall thickness at several locations, leading to live leaks needing to be repaired.

- * 1). Leaking pipe once the support was removed. ,
- * 2). Plate bond using Belzona 1212 and held in place using a strap during the polymerisation stage. ,
- * 3). Belzona 5811 applied over the plate to prevent any future corrosion in the area. ,
- * 4). Completed application, overcoated with Belzona 5811. ,

Supports were erected at either side of the original pipe support. The live leak was then plugged at the various locations using Belzona 9611 in order to divert the leak to one single area. A 10mm plate with a threaded outlet was then cold bonded using Belzona 1212 due to its very short polymerisation window and held in place using a strap. Once fully cured, a threaded screw was threaded into the plate to stop the leak, followed by 2 coats of Belzona 5811 applied over the plate to prevent any corrosion occurring again in the area. The application was carried out in accordance with modified version of Belzona System Leaflet VPF-11.
