BELZONA PROTECTS BRINE PUMP BOWLS

ID: 885

Customer Location: Hydrocarbon Fractionation Facility /
Hutchinson, KS

Application: CEP-Centrifugal Pumps

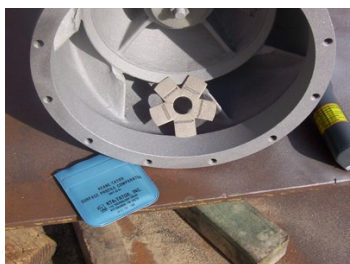
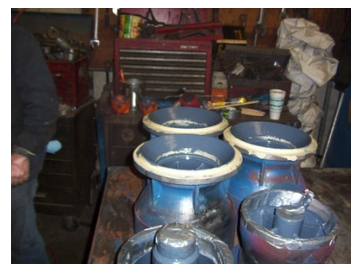
Salt brine is pumped into the ground to force stored petroleum out of storage for processing. The pumps suffer from the effects of erosion/corrosion caused by the brine.

* Grit blasted bowl with surface profile sample , * Mixing Belzona® 1321 , * Application under supervision in progress , * Pump bowls with Belzona® 1321 applied ,

Application was completed in accordance with Belzona Know-How System leaflet CEP-3.
The pump bowls were heated to a pre-application temperature of 90°F.
