# BELZONA PROTECTS BRINE PUMP BOWLS

ID: 885

Customer Location: Hydrocarbon Fractionation Facility /  
Hutchinson, KS

Application: CEP-Centrifugal Pumps

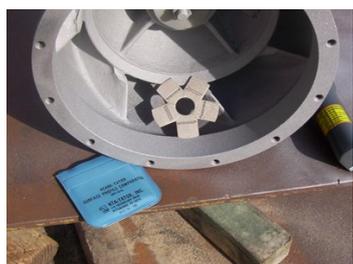
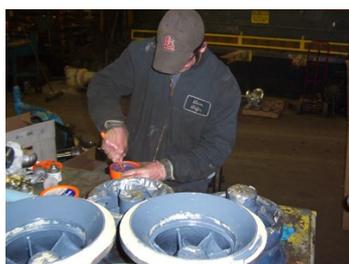
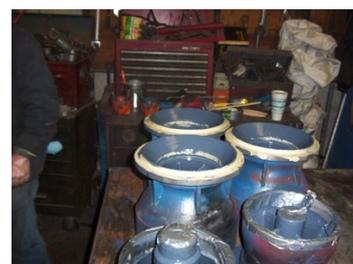
\* Grit blasted bowl with surface profile sample , \* Mixing Belzona® 1321 , \* Application under supervision in progress , \* Pump bowls with Belzona® 1321 applied ,

Application was completed in accordance with Belzona Know-How System leaflet CEP-3.  
The pump bowls were heated to a pre-application temperature of 90°F.
