# Corroded vessel repaired with Belzona Superwrap II

**Industry:** *General Industry*  
**Application:** *TCC-Tanks and Chemical Containment Areas*  
**Substrate:** *Carbon steel*  
**Products:** *Belzona 1511 (Super HT-Metal),  
Belzona 1983,  
Belzona 9381,*

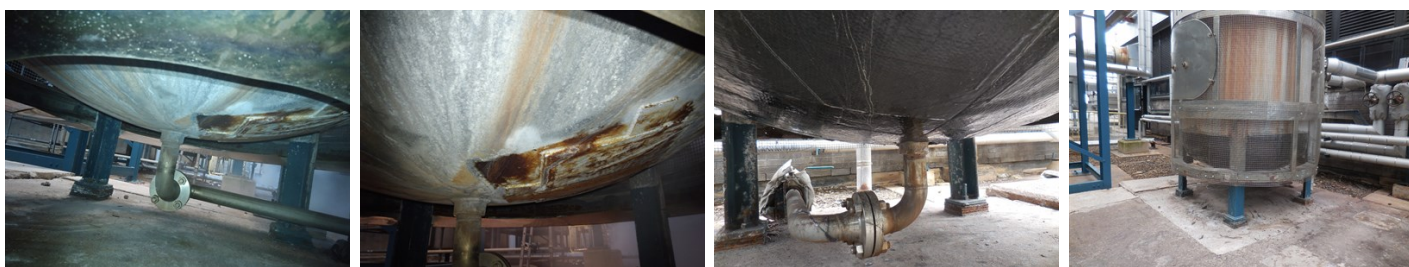
*Welding had been attempted but had failed, leaks reappeared around the welded seams of the doubler plates that had been installed.*

A vessel containing steam & condensate had developed several leaks due to corrosion on the bottom dome.

The vessel was grit blasted to achieve a surface profile. The welded plates were then skimmed with Belzona 1511 & any corroded areas filled. Following this four layers of Belzona Superwrap 2 were applied as a patch repair system across the full bottom dome of the vessel. Belzona 9382, mixing boards & ratchet straps were used together to consolidate the repair.

The Belzona repair was carried out over three days saving much downtime for the plant. This system avoided introducing further heat into the already weakened metal. The full encapsulation of the bottom dome ensures even if further leaks develop in the metal they will be contained by the Belzona system.
