# Corroded flange area rebuilt with Belzona

ID: 8853

Application: VPF-Valves, Pipes and Fittings

Application Date: July 2022

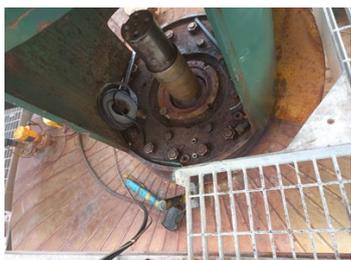
Corroded area around mechanical seal

A mild steel flange section at the top of a vessel had become corroded due to leaking acetic acid. A repair was required to reinstate the lost metal & provide future protection.

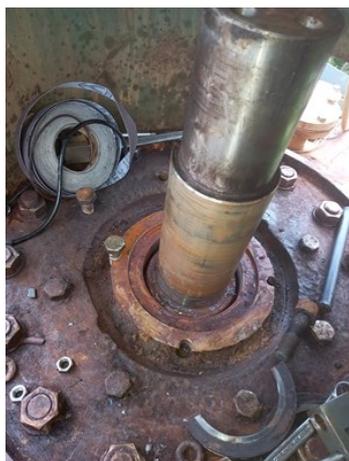
Close up

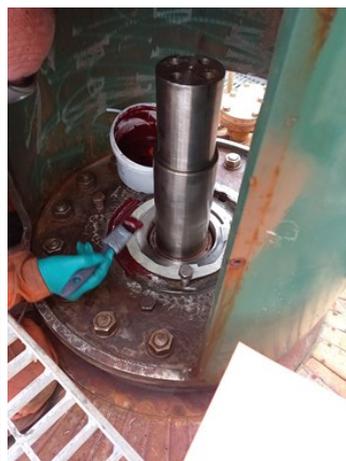
Area prepared & wetted out with Belzona 4331

The corroded area was prepared using power tools to achieve a surface profile. It was degreased & Belzona 9411 release agent was applied to the bolts that fitted around the mechanical seal housing. Belzona 4331 was then used to wet out the area before being poured in to fill the areas of metal loss.

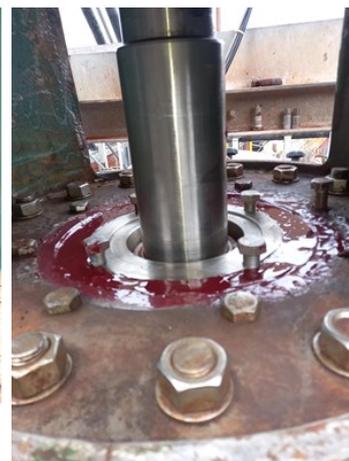
Belzona 4331 filled to replace the lost metal
