# Belzona Superwrap II Restores Strength to 26 Metre Sewage Pipeline

**Industry:** Water / Wastewater  
**Application:** VPF-Valves, Pipes and Fittings  
**Substrate:** Carbon Steel  
**Products:** \* Belzona SuperWrap II ,  
\* Belzona 1121 (Super XL-Metal) ,  
\* Belzona 4131 (Magma-Screed) ,

**Customer Location:** Water Authority, Scotland  
**Application Date:** August, 2021

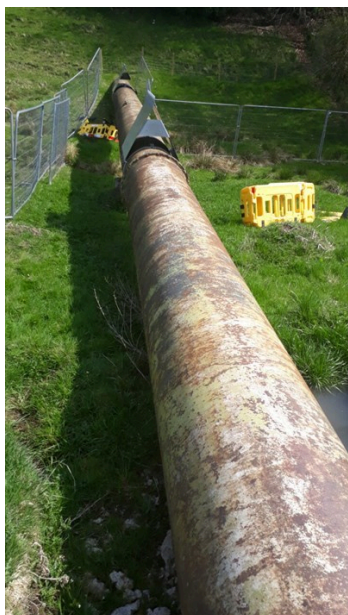
The heavily corroded, 900mm diameter pipe is the main sewage line for a nearby town and if the issue was not rectified, there would be a huge cost for the asset owner. Pipe replacement was not an option due to complications in isolating this section. As this type of overland pipe is exposed to the elements, it often corrodes more than buried sections.

- \* 1. Corroded sewage pipe ,
- \* 2. Plate bonded in place ,
- \* 3. Completed wrap, Release film in place, Fabricated box ,
- \* 4. Pipe back in service with Belzona SuperWrap II completed ,

Firstly, the area was cleaned, and the pipe surface was grit blasted to the required standard. The live leaks were repaired by bonding prefabricated Belzona SuperWrap II plates over the leaking areas using Belzona 1121 (Super XL-Metal). Next, to provide complete protection, three layers of Belzona Superwrap II were mixed and applied to the external surface of the pipe. Once the pipe wraps had been applied, Belzona 9382 release film was applied around the wrap system and allowed to cure overnight.
