Belzona seals bridge leaks

ID: 8863

Industry: General Industry
 Application: TCC-Tanks and Chemical Containment Areas
 Substrate: Carbon steel
 Products: Belzona 1121 (XL Metal),

Customer Location: Scotland
 Application Date: August 2022

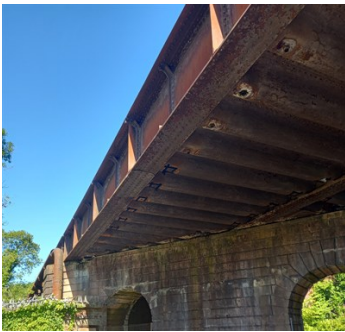
Bridge with leaking sections

A bridge had several gaps where water could penetrate & drip down onto a waterway below. A solution was required to seal these leak points.

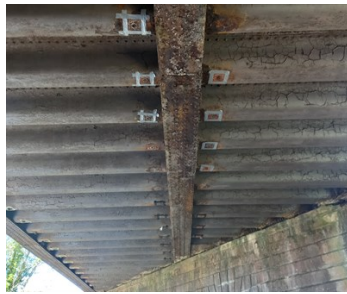
Areas marked out

The gaps were first marked out & prepared with an angle grinder. Suitably sized plates were sourced & prepared in the same way. The plates were then bonded to the surface. The slump resistance of the Belzona material was sufficient to hold the plates in place with no additional shuttering, saving time & cost.

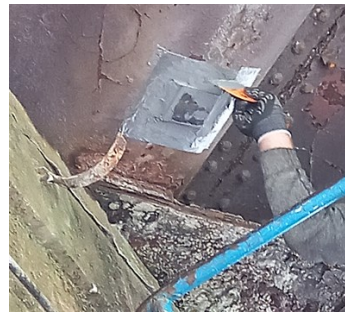
Belzona 1121 plate bonding

Belzona 1121 was used due to its extended working life, this feature was beneficial on this application as the works were carried out from a MEWP & time was needed to position in between the plate applications.

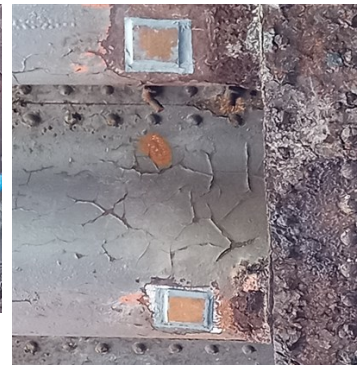
Application 18 months later

The application was reviewed 18 months later and is in perfect condition
