Belzona seals bridge leaks

ID: 8863

Industry: General Industry
 Application: TCC-Tanks and Chemical Containment Areas
 Substrate: Carbon steel
 Products: Belzona 1121 (XL Metal),

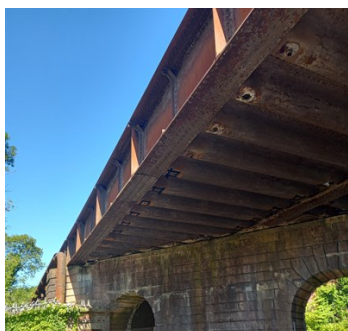
Bridge with leaking sections

A bridge had several gaps where water could penetrate & drip down onto a waterway below. A solution was required to seal these leak points.

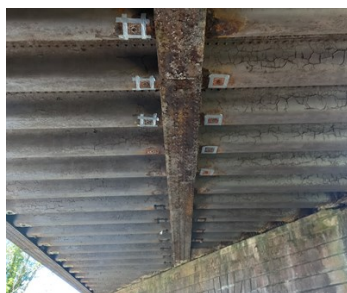
Areas marked out

The gaps were first marked out & prepared with an angle grinder. Suitably sized plates were sourced & prepared in the same way. The plates were then bonded to the surface. The slump resistance of the Belzona material was sufficient to hold the plates in place with no additional shuttering, saving time & cost.

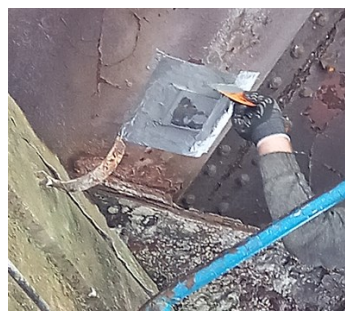
Belzona 1121 plate bonding

Belzona 1121 was used due to its extended working life, this feature was beneficial on this application as the works were carried out from a MEWP & time was needed to position in between the plate applications.

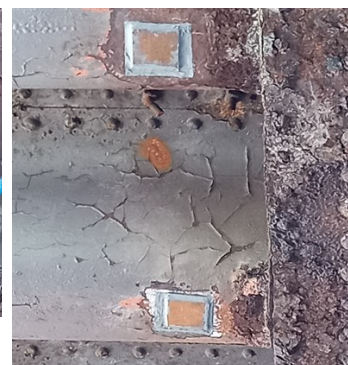
Application 18 months later

The application was reviewed 18 months later and is in perfect condition
