Belzona seals the base of storage tank

ID: 8865

Industry: *Chemical & Petrochemical*
Application: *GSS-Gaskets, Seals and Shims*
Substrate: *Carbon steel*
Products: *Belzona 3921*
Belzona 3131 WG Membrane
Belzona 9311

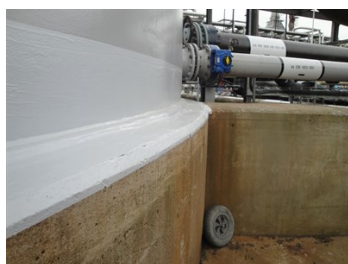
Original mastic failure

A large diameter storage tank had a mastic seal installed between its annular rim & concrete base. This mastic had become disbonded due to its lack of flexibility. A solution was required to seal this gap to prevent corrosion whilst maintaining flexibility.

The seal area on the newly painted tank was marked out & abraded to a 40 micron profile. Belzona 3921 was then applied followed by two coats of Belzona 3131 incorporating the 9311 reinforcing sheet.

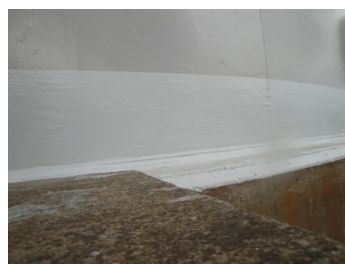
Close up of application

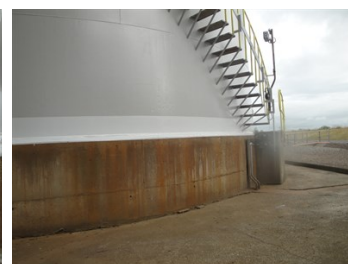
Completed application

The system has now been used on many tanks onsite & proved effective at preventing water ingress long term.
