BELZONA SEALS CONDENSER EXPANSION JOINT

ID: 887

Customer Location: Energy company, Kansas, USA

Application Date: March 2007

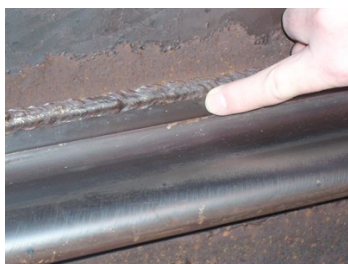
The efficiency of the unit was low because of the leaks in the expansion joint.

- * Leaking expansion joint ,
- * Mixing Elastomer ,
- * First coat ,
- * Second & Third coat ,

Application was carried out in accordance with Belzona Know-How System Leaflet HEX-5. The surface was prepared with a vacublast unit. After Conditioning, three coats of Elastomer were applied to the expansion joint and approximately one inch beyond the joint.
