# Belzona Refurbishes a heat exchanger in the Sugar Industry

Application: HEX-Heat Exchangers

Application Date: August 2022

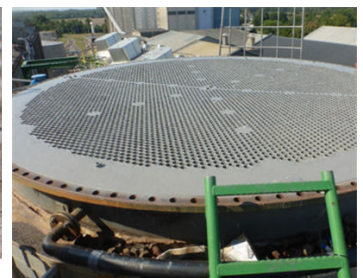
The head plate of the heat exchanger was very badly corroded and was already showing in part considerable loss of wall thickness.

- \* 1: Blasting Surface ,
- \* 2: Surface after Blasting ,
- \* 3: Application of Belzona 1511 ,
- \* 4: Completed application with Belzona 1391S ,

The plate was blasted in accordance with the Belzona IFU. The plate was washed twice with Saltaway + deionized water + blown dry. The application was carried out in accordance with Belzona System Leaflet HEX-1 and HEX-3.
