Belzona Weatherproofs Instrumentation Control Roof

ID: 8875

Application: RPA-Roof Problem Areas

Building roof (240m²) of an Instrumentation & Control office within a Petrochemical Depot.

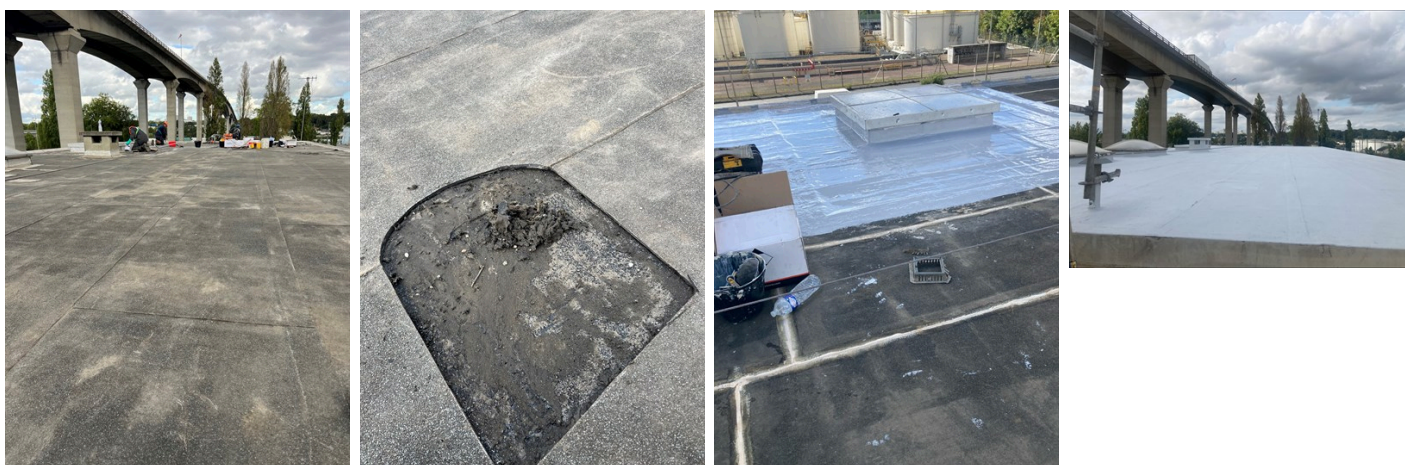
Photograph Descriptions

- * 1). Roof after the gravel was removed. ,
- * 2). Close-up of are where roofing felt had to be removed due to rot. ,
- * 3). Post-application of Belzona Stripe Coating on all edges and entry-points around the skylight. ,
- * 4). Finished application with 2x coats of Belzona 3111 and Reinforcement Sheet. ,

The roof covered in gravel had been leaking water into the building for years. This issue worsened after the installation of a new skylight over 12-months ago, causing serious damage to the buildings internal walls.

The application was carried out in accordance with Belzona System Leaflet RPA-01 & RPA-02.
