Belzona Weatherproofs Instrumentation Control Roof

ID: 8875

Building roof (240m²) of an Instrumentation & Control office within a Petrochemical Depot.

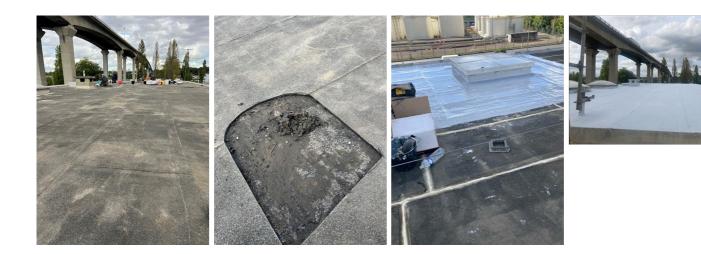
Photograph Descriptions

The roof covered in gravel had been leaking water into the building for years. This issue worsened after the installation of a new skylight over 12-months ago, causing serious damage to the buildings internal walls.

- * 1). Roof after the gravel was removed.,
- * 2). Close-up of are where roofing felt had to be removed due to rot. ,
- * 3). Post-application of Belzona Stripe Coating on all edges and entry-points around the skylight.,
- * 4). Finished application with 2x coats of Belzona 3111 and Reinforcement Sheet. ,

The application was carried out in accordance with Belzona System Leaflet RPA-01 & RPA-02.
