BELZONA SEALS POROUS TANK WELDS

Customer Location: Herbicide Manufacturer- Bushton,
Kansas, USA

Application: TCC-Tanks and Chemical Containment
Areas

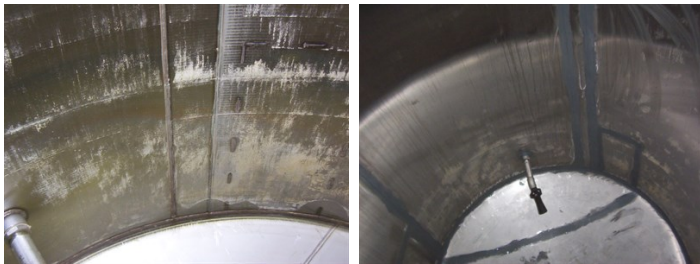
Photograph Descriptions

Porous welds in stainless steel tank. Herbicide is expensive and very slippery. Not only was leaking tank an environmental hazard but a general safety hazard as well.

* Tank interior before application , * Tank seams coated with Belzona® 4301 ,

Application carried out in accordance with Belzona System Leaflet TCC-1. The tank was drained and rinsed. A stainless steel tank cleaner was used to clean the surface.

After preparing the surface,

Two coats of Belzona® 4301 were applied to the weld seams.
