Protection of the discharge pipe area on ship

ID: 8880

Industry: *Marine*
Application: *SOS-Ships and Offshore Structures*

Customer Location: *Port of Odense (Lindoe ship yard)*
Application Date: *26-10-2022*

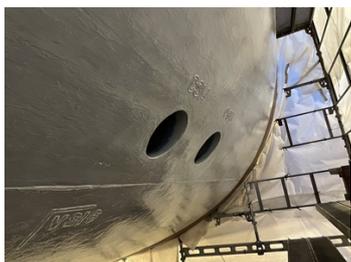
*The original glass flake coat had broken after a few years in service.
This leaves the ship unprotected and vulnerable to corrosion.*

initial condition of ship

The area was grit blasted, roughness was measured and the salt contamination determined (result ok)
Two coats of 1391T were applied

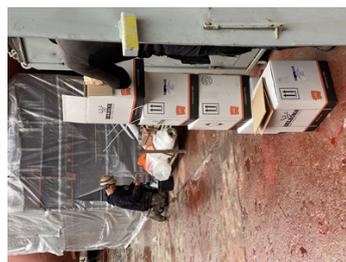
during application

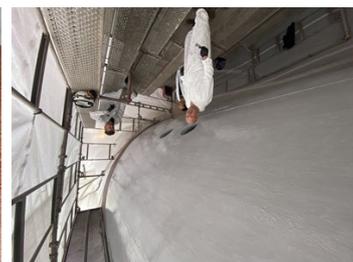
application complete
