# Protection of the discharge pipe area on ship

ID: 8880

Industry: *Marine*  
Application: *SOS-Ships and Offshore Structures*

Substrate: *Carbon steel*  
Products: *Belzona 1391T*

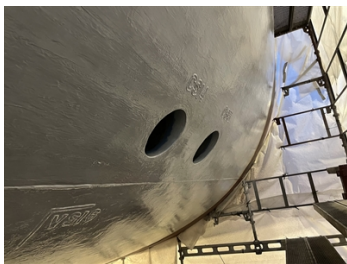
*The original glass flake coat had broken after a few years in service.  
This leaves the ship unprotected and vulnerable to corrosion.*

initial condition of ship

The area was grit blasted, roughness was measured and the salt contamination determined (result ok)  
Two coats of 1391T were applied

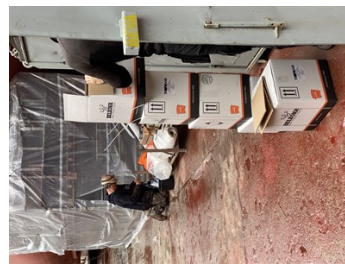
during application

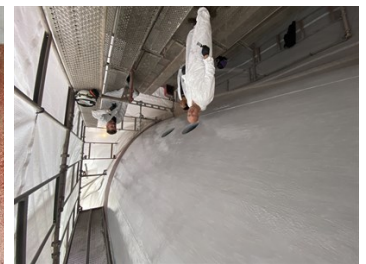
application complete
