BELZONA REPAIRS NEW HEAVY EQUIPMENT TIRE

ID: 889

Application: SHM-Solids Handling Machinery

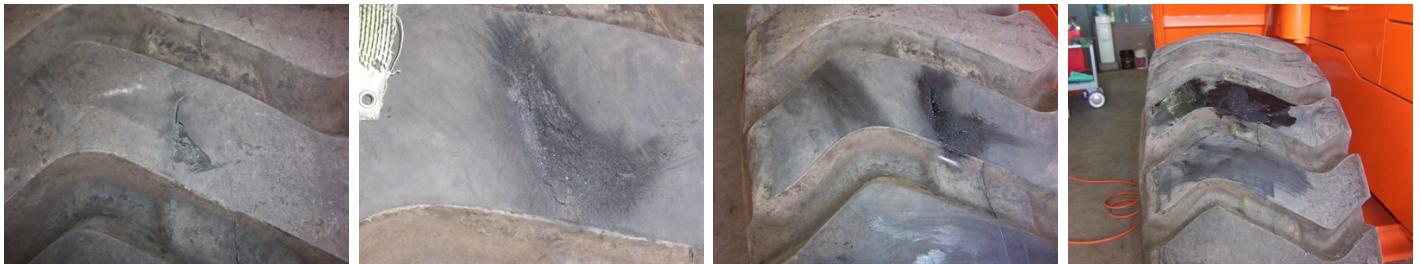
Photograph Descriptions

When the transport unloaded this brand new loader, the tire was damaged.

- * Damaged portion of the tire ,
- * Roughened surface ,
- * Surface conditioned ,
- * Tire rebuilt with Belzona® 2311 ,

The application was carried out in accordance with Belzona Know-How System Leaflet SHM-1. The surface was prepared with a roughing brush and conditioned with Belzona® 2911 (QD Conditioner). The gouges in the rubber tire cover were rebuilt with Belzona® 2311.
