# Belzona repairs & protects Phosphoric Acid Bund

ID: 8914

Application: TCC-Tanks and Chemical Containment Areas

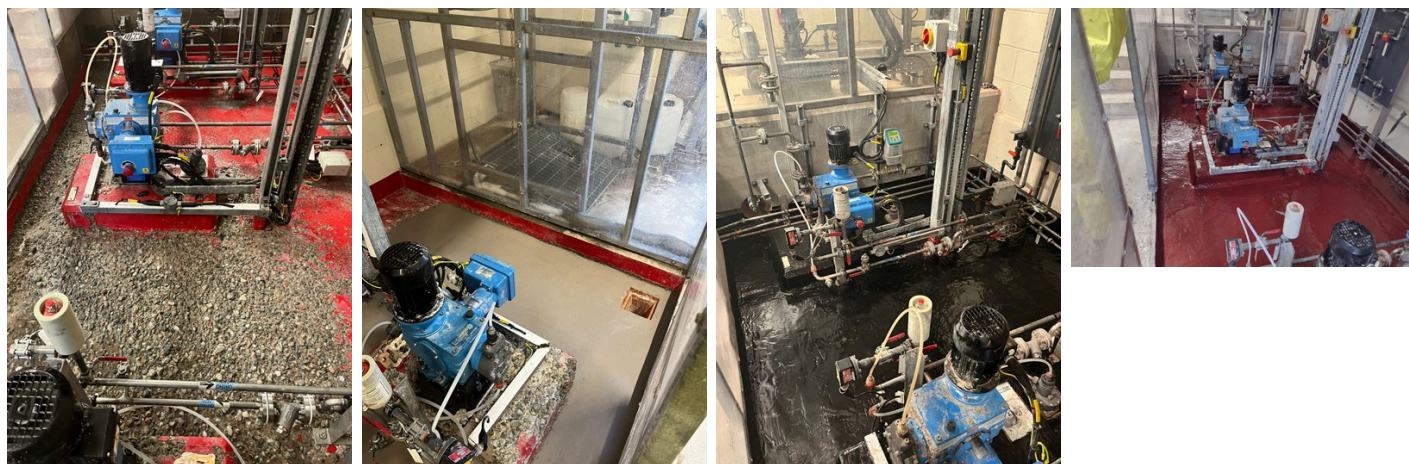
The previous coating within the bund had been corroded away leaving the underlying concrete susceptible to damage. A long term repair & protective solution was required.

A bund containing several pumps had become severely corroded due to Phosphoric acid leaks. Significant sections of concrete had been affected by the acid.

The bund was prepared using a high pressure wash. This removed the damaged sections of concrete & decontaminated the remaining concrete.

Belzona 4911 TX Conditioner was applied followed by Belzona 4131 Magma Screed to bring the corroded areas back up to the original floor level.

Two coats of Belzona 4341 CR4 were then applied for long term acid protection.
