# BELZONA PROTECTS A CONTAINMENT AREA

Industry: Power  
Application: FPA-Floor Problem Areas  
Substrate: Concrete  
Products: Belzona 5811 (Immersion Grade)

Customer Location: HPP Banje, Gramsh  
Application Date: April 2021

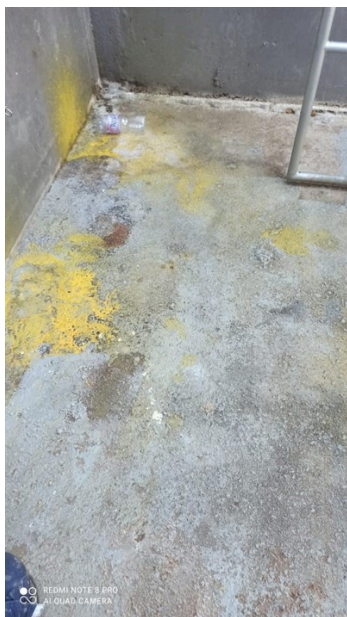
Pictures before application

Protection of deteriorated floors and walls in oil leaks containment areas.

The floor had started to deteriorate due to oil and water ingress. The client analysed and tested several materials with no results. The physical and mechanical properties including adhesion testing of the Belzona provided the reassurance the client needed to select Belzona for protection and to ensure that coating would have the required longevity.

The Hydropower plant required a protective coating for the transformer oil containment area . The coating should be able to withstand oil penetration in concrete in case of leaks from the transformers.

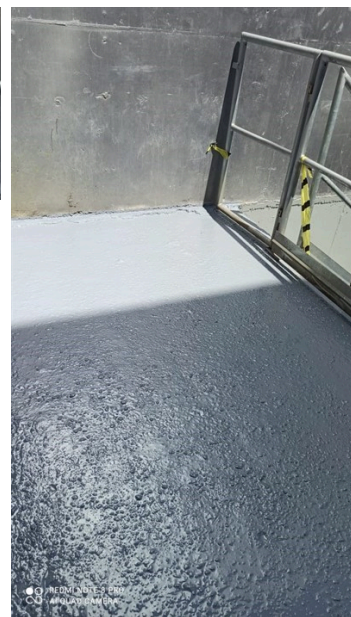
Containment Area after application

Application carried out in accordance with Belzona System Leaflet FPA-3.
