BELZONA FLANGE REFORM GIVES FIVE YEARS OF LEAK FREE SERVICE

ID: 893

Customer Location: FPSO North Sea, UK
 Application Date: August 2002

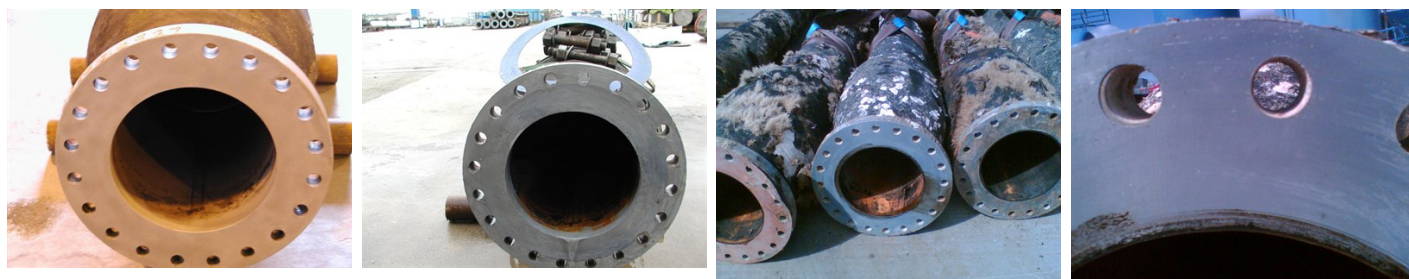
Photograph Descriptions

Hose failed its pressure test prior to being built into a replacement string.

* Flange face blasted ready for forming , * Face formed and pressure tested to 16 Bar , * After 5 years service , * Close up of the reformed face after 5 years service ,

Application carried out in accordance with Belzona System Leaflet VPF-13.

Hose would have been scrapped at a cost of £25,000.00, the string change out would have been delayed leading to a reduction in the unloading frequency from the FPSO. Belzona repair in excellent condition after 5 years in service.
