Shaft repair on Screw Conveyor

Industry: Pulp & Paper
Application: MPT-Mechanical Power Transmission

Customer Location: Crofton, BC
Application Date: January 2023

Substrate: Carbon steel
Products: Belzona 1321 (Ceramic S-Metal)

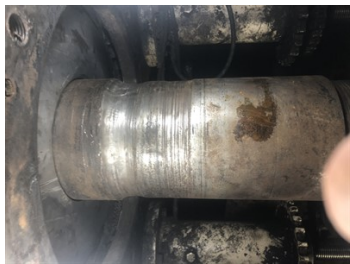
The customer had a bearing failure which resulted in sever metal loss on the shaft.

Damaged shaft

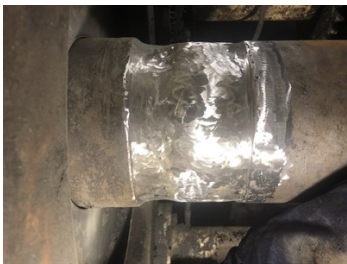
Surface prep in progress

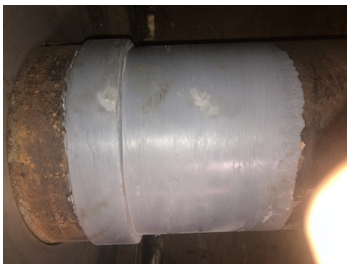
Completed repair
