Shaft repair on Screw Conveyor

Industry: Pulp & Paper
Application: MPT-Mechanical Power Transmission

Substrate: Carbon steel
Products: Belzona 1321 (Ceramic S-Metal)

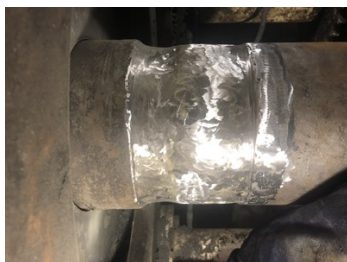
Surface prep in progress

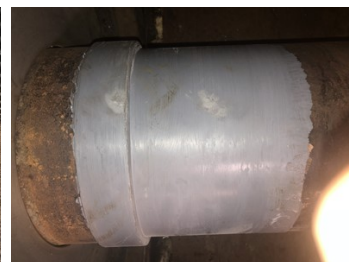
Completed repair
