PELTON TURBINE NOZZLE HEAD

ID: 8935

Problem

Cavitation damage on the substrate due to high pressure on the nozzle head

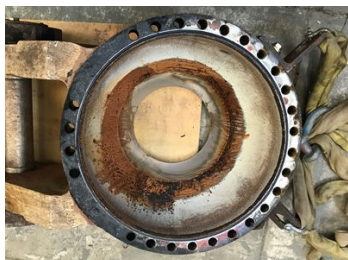
Before / Damage on the Nozzle head

Cavitation was present due to high pressure and high flow rate at the tip of the pelton turbine nozzle head.

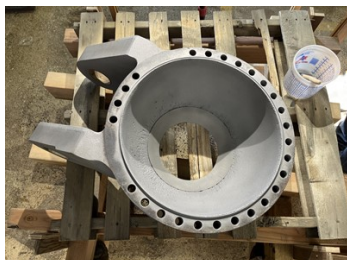
After abrasive blasting to SSPC SP-10/3 mil profile Surface Preparation

Blasting to SSPC SP-10/3 mil profile Surface Preparation. Hand application using short bristled brush and applicator. Belzona 1341 was applied to the blasted substrate. Belzona 2941 conditioner was applied to the Belzona 1341 for correct adhesion with the Belzona 2141 topcoat. Belzona 2141 was applied in a 2 coat system.

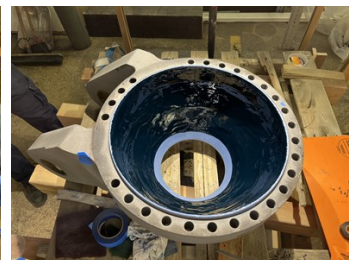
Belzona 2141 applied as a topcoat to protect against future cavitation damage
