Belzona Stops Live Leak

ID: 8937

Industry: *Pulp & Paper*
Application: *TCC-Tanks and Chemical Containment Areas*
Substrate: *Carbon steel*
Products: *Belzona 1212, Belzona 9611 (ES-Metal)*

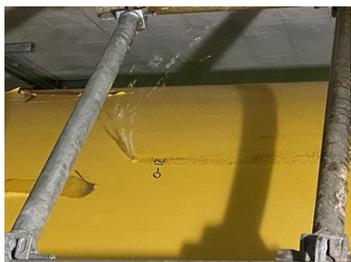
Leak developed in dissolving tank due to corrosion because of liner failure.

Leak as found

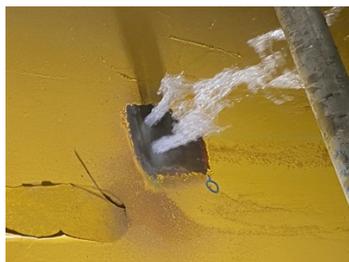
Surface Preparation completed with MBX

Area prepped with bristle blaster and leak stopped with Belzona 9611. The repair was then consolidated with Belzona 1212 and the 9341 reinforcement mesh for higher pressure retention and a more long term repair.

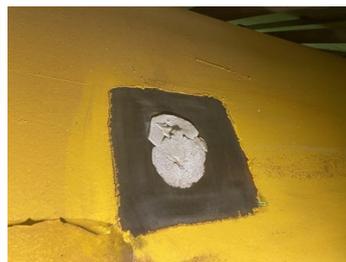
Leak stopped with Belzona 9611

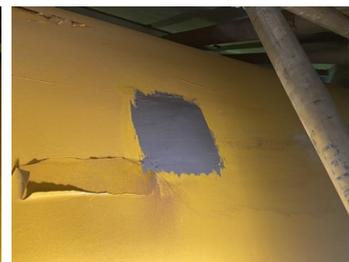
Area reinforced with Belzona 1212/9341 Mesh
