Belzona Stops Live Leak

ID: 8937

Industry: *Pulp & Paper*
Application: *TCC-Tanks and Chemical Containment Areas*
Substrate: *Carbon steel*
Products: *Belzona 1212, Belzona 9611 (ES-Metal)*

Customer Location: *Central BC*
Application Date: *2019*

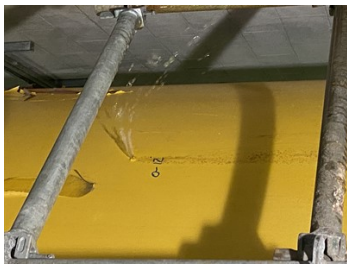
Leak developed in dissolving tank due to corrosion because of liner failure.

Leak as found

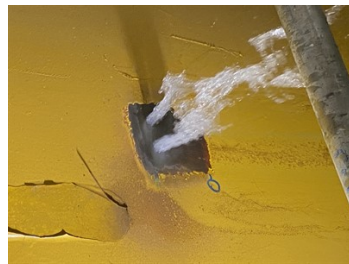
Surface Preparation completed with MBX

Area prepped with bristle blaster and leak stopped with Belzona 9611. The repair was then consolidated with Belzona 1212 and the 9341 reinforcement mesh for higher pressure retention and a more long term repair.

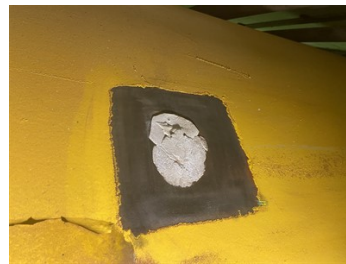
Leak stopped with Belzona 9611

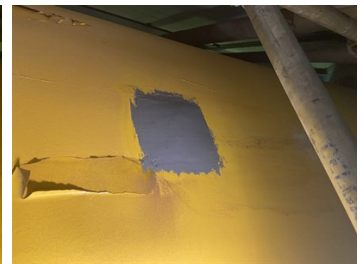
Area reinforced with Belzona 1212/9341 Mesh
