Belzona Superwrap 2 system repairs storage tank

ID: 8945

Application: TCC-Tanks and Chemical Containment Areas

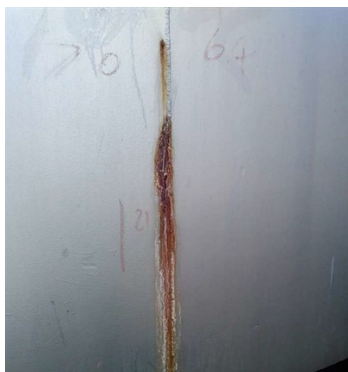
A leak had developed in a storage tank due to corrosion.

Leaking area

The area was prepared with an MBX Bristle Blaster to SSPC SP11. A cold plate bond was then applied using Belzona 1111. This plate was then encapsulated with Belzona Superwrap 2

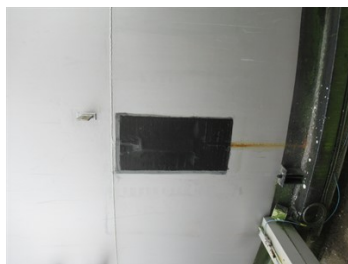
Belzona 1111 & Superwrap 2 applied
