Belzona Superwrap 2 system repairs storage tank

Industry: *Chemical & Petrochemical* Customer Location: *Scotland*
Application: *TCC-Tanks and Chemical Containment Areas* Application Date: *January 2023*
Substrate: *Carbon steel*
Products: *Belzona 1111 (Super Metal), Belzona 1981 (SuperWrap II)*

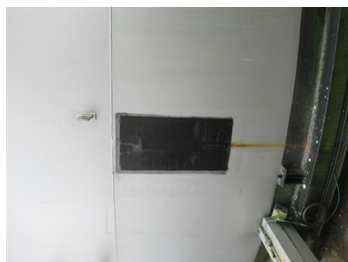
Belzona 1111 & Superwrap 2 applied

The area was prepared with an MBX Bristle Blaster to SSPC SP11. A cold plate bond was then applied using Belzona 1111. This plate was then encapsulated with Belzona Superwrap 2
