Much Debris Found Under Metal Plate Outside of OR in Local Hospital

Industry: Other
Application: FPA-Floor Problem Areas
Substrate: Concrete
Products: Belzona 2211 (MP Hi-Build Elastomer), Belzona 2911 (Elastomer QD Conditioner), Belzona 4111 (Magma-Quartz), Belzona 4411 (Granogrip), Belzona 4911 (Magma TX Conditioner)

Customer Location: Piedmont, NC, USA
Application Date: February 2023

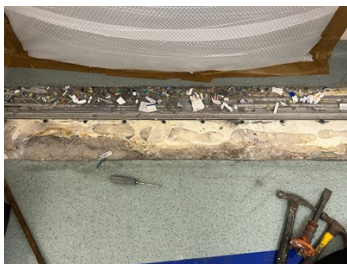
The metal plate covering the expansion joint outside an operating room in a sterile area was trip hazard because the plate was lifting up and separating from the floor. Several employees had tripped and surgical carts toppled from the plate.

Removal of plate reveals extensive amount of debris in a sterile area at doorway to operating room.

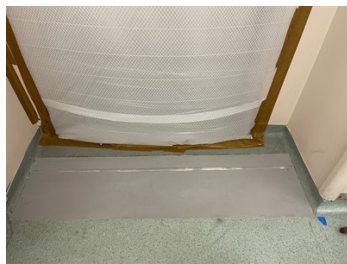
After the plate was removed, the joint was cleaned out and Belzona 4111 was applied to build out the joint nosings.

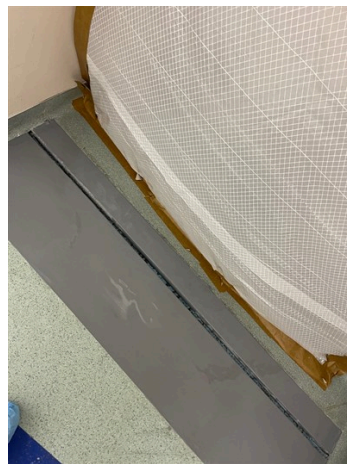
Once Belzona 4111 cured, a thick coating of Belzona 4411 was applied. It was chosen for its fast cure and durability.

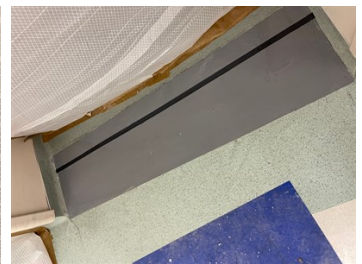
Last step was to condition the joint area with Belzona 2911 and tape off / fill with Belzona 2211 Elastomer.

Manual tools were used to remove the plate and the grinder for joint nosing preparation work. The Belzona 4111 application was done with trowel after the area was taped off. Belzona 4411 was applied with a stiff bristle brush after the Belzona 4111 had cured sufficiently. Next morning the joint space was grinded a little to allow for adhesion of the Belzona 2211 which was applied using a Belzona applicator. The area was returned to service in under 24 hours.
