Recycled Acid Containment Concrete Repair & Coating

Application: TCC-Tanks and Chemical Containment Areas

Substrate: Concrete

Products: Belzona 4111 (Magma-Quartz), Belzona 4311 (Magma CR1)

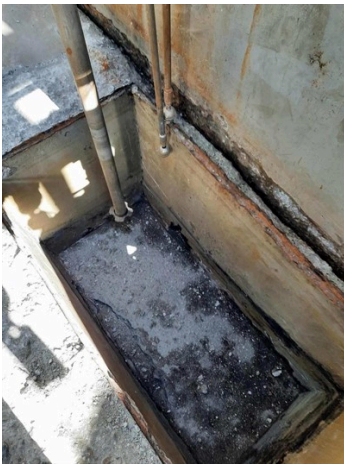
A rubber lined recycled acid day tank occurred a leak in a seam in the liner and exposed the containment to acid. The acid filled the secondary containment almost 2 foot deep and destroyed the previous coating. Over time and years of exposure during filling the small amounts that leaked from the flange and hose caused the damage to the sump pit area.

Damage to the sump pit area.

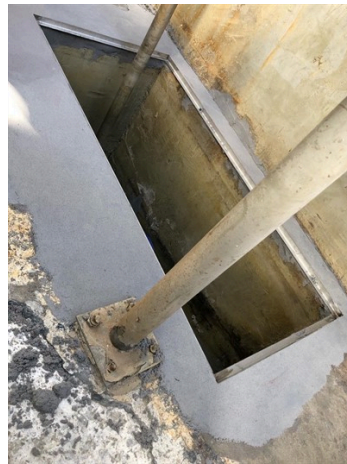
Repairs that were made using Belzona 41111.

In this application we started the process by first pressure washing and neutralizing the concrete to remove any containments and debris. Then there were several cracks we repaired during this project. We drilled the cracks out to stop them from expanding further then created a V in the cracks using hand held grinding tools with diamond disc. We used the same process for the sump pit area. Once all areas were prepped following Belzona guidelines we then made the repairs using hand held tools reforming the sump pit area and coating the containment using hand rollers.

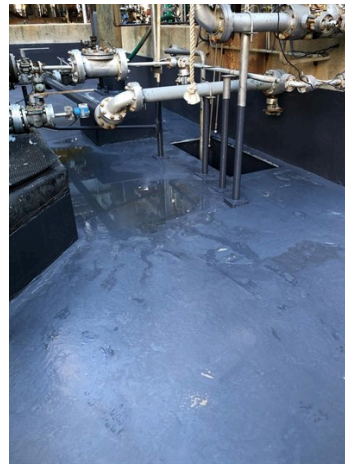
Finished repair and coating. Belzona 4311 was used.
