Recycled Acid Containment Concrete Repair & Coating

ID: 8951

Application: TCC-Tanks and Chemical Containment Areas

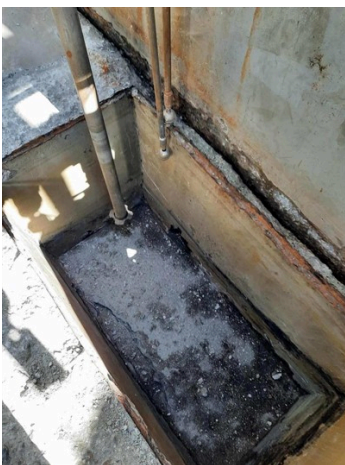
A rubber lined recycled acid day tank occurred a leak in a seam in the liner and exposed the containment to acid. The acid filled the secondary containment almost 2 foot deep and destroyed the previous coating. Over time and years of exposure during filling the small amounts that leaked from the flange and hose caused the damage to the sump pit area.

Damage to the sump pit area.

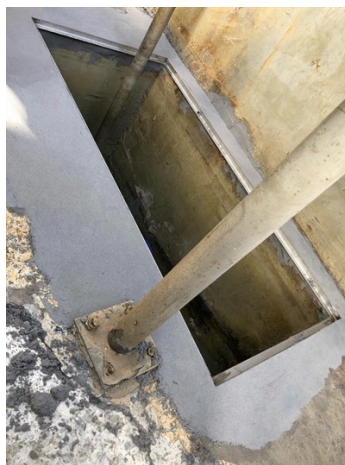
Repairs that were made using Belzona 4111.

In this application we started the process by first pressure washing and neutralizing the concrete to remove any containments and debris. Then there were several cracks we repaired during this project. We drilled the cracks out to stop them from expanding further then created a V in the cracks using hand held grinding tools with diamond disc. We used the same process for the sump pit area. Once all areas were prepped following Belzona guidelines we then made the repairs using hand held tools reforming the sump pit area and coating the containment using hand rollers.

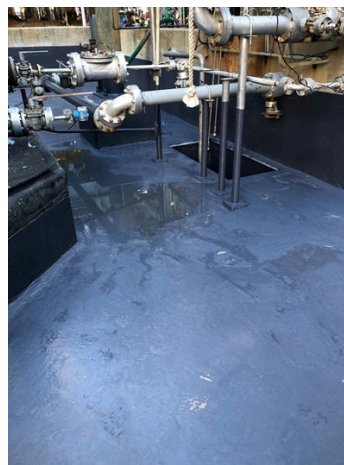
Finished repair and coating. Belzona 4311 was used.
