# Recycled Acid Containment Concrete Repair & Coating

ID: 8951

**Application:** TCC-Tanks and Chemical Containment Areas

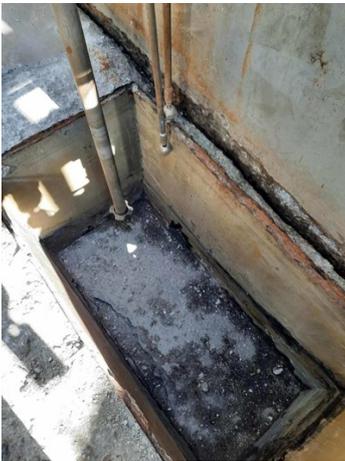
A rubber lined recycled acid day tank occurred a leak in a seam in the liner and exposed the containment to acid. The acid filled the secondary containment almost 2 foot deep and destroyed the previous coating. Over time and years of exposure during filling the small amounts that leaked from the flange and hose caused the damage to the sump pit area.

Damage to the sump pit area.

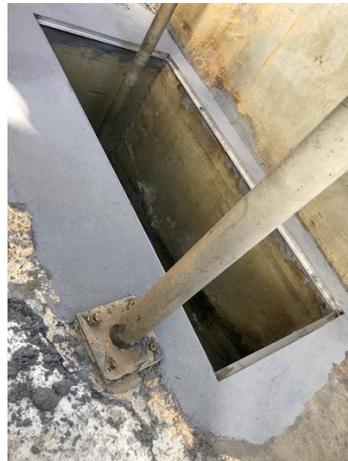
Repairs that were made using Belzona 41111.

In this application we started the process by first pressure washing and neutralizing the concrete to remove any containments and debris. Then there were several cracks we repaired during this project. We drilled the cracks out to stop them from expanding further then created a V in the cracks using hand held grinding tools with diamond disc. We used the same process for the sump pit area. Once all areas were prepped following Belzona guidelines we then made the repairs using hand held tools reforming the sump pit area and coating the containment using hand rollers.

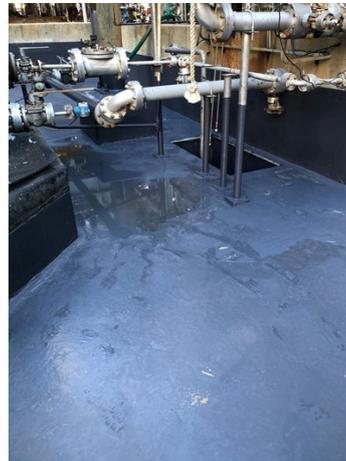
Finished repair and coating. Belzona 4311 was used.
