Belzona repairs sprinkler tank

Application: TCC-Tanks and Chemical Containment Areas

Substrate: Carbon steel

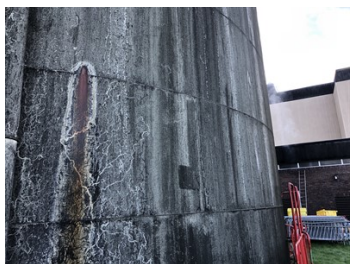
A pinhole leak had developed on the side of a sprinkler tank

Leak on tank

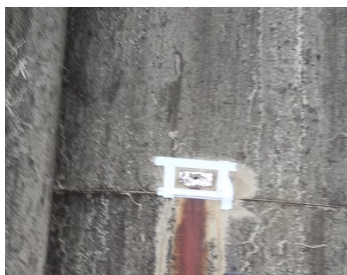
Initial surface preparation

The initial area was first prepared back to bare metal & the leak was sealed with Belzona 9611. Once this was done the larger area was prepared using an angle grinder. A plate was then bonded in place using Belzona 1161 UW Metal

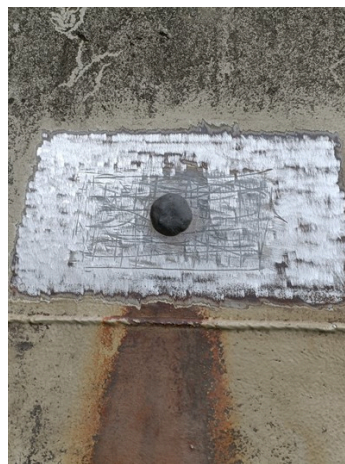
Leak sealed with Belzona 9611 & additional surface preparation carried out

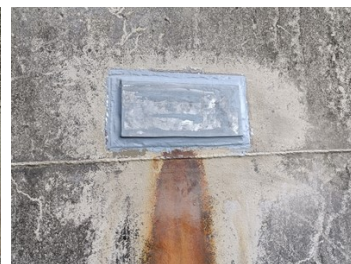
Plate bonded in place with Belzona 1161

By using the Belzona repair system the repair was able to be completed without damaging the tank's internal lining.
