Belzona Repairs and Protects Spillway from Leaking Oil

Substrate: *Concrete*

Products: *Belzona 4111 (Magma-Quartz), Belzona 5831 (ST-Barrier), Belzona 9111 (Cleaner Degreaser)*

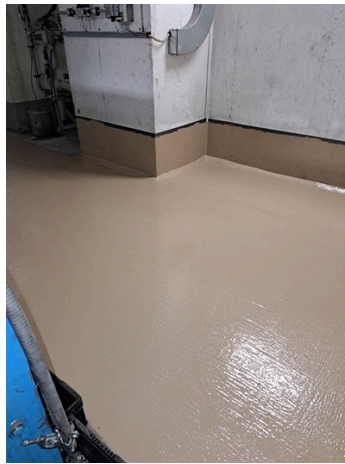
Belzona 4111 (Magma-Quartz) was used to build a cove at the joints with the perimeter walls, and overcoated with Belzona 5831 (ST-Barrier)

After 90 days, the trial patch was in excellent condition, leading to the Customer giving their approval for two of the four press pits to be coated during planned seasonal shutdowns. The results of years of oil seepage meant that the substrate required extensive cleaning using Belzona 9111 (Cleaner/Degreaser), steam cleaners and heated pressure washers to get the concrete as clean as possible for the application. The entire surface profile was then prepared using a diamond grinder to facilitate adhesion of Belzona 5831 (ST-Barrier), before a one inch cove was built using Belzona 4111 (Magma-Quartz) at the joints between the floor and the perimeter walls to relieve pressure from the seams. One coat of Belzona 5831 (ST-Barrier) was applied to sumps, flooring and to the

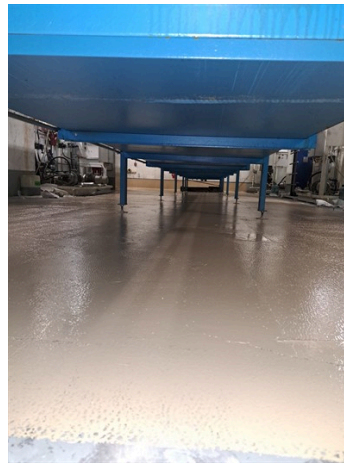
Final coat of Belzona 5831 (ST-Barrier) being applied to all accessible areas

bottom 12 inches of the walls at eight to ten mils Wet Film Thickness (WFT). Before the product had cured, Aluminium Oxide was spread at a rate of 50lbs per 100 square feet to create the desired tread. Finally, a top coat of Belzona 5831 (ST-Barrier) was applied at 10 to 12 mils WFT.

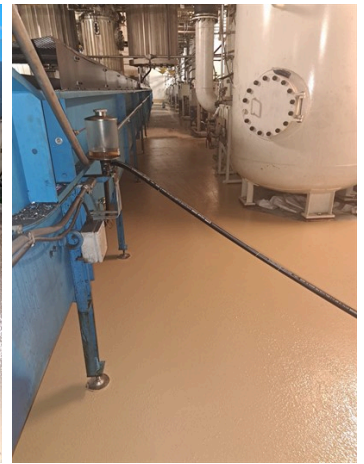
The concrete underneath the conveyor lines were protected and made safer by the repair

Subsequent site visits have shown that the coating is protecting the concrete extremely effectively and the tread is also much safer to walk on. The Customer was very pleased with the work and now has plans to coat the concrete underneath the two remaining conveyor lines and several other press pits, thanks to the success of the Belzona repair.
