# LUXURY YACHT P FRAMES PROTECTED FROM CAVITATION WITH BELZONA® 2141

Propeller shaft support brackets of a luxury yacht. This craft is 46.63m long and equipped with a 13,000hp CODAG power plant capable of 50 Knots through a combined twin-prop and waterjet arrangement.

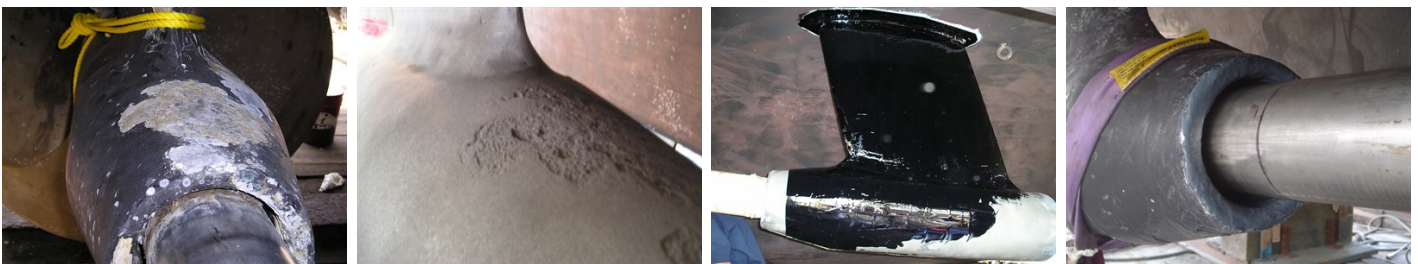
*Cavitation had caused erosion of the parent metal and threatened the structural strength of the component if left untreated.*

- \* Original condition of component ,
- \* Close up of cavitation damage ,
- \* Belzona® 2141 mid application ,
- \* Belzona® 2141 after 12 months (overcoated with antifouling) ,

Application was carried out in accordance with Belzona Know-How System Leaflet SOS-2. A conventional anti-fouling was applied over the Belzona® 2141.

Inspection of the Belzona® 2141 system after 12 months service in this aggressive environment showed no attack to the Belzona coating.
