BELZONA SEALS TAILSHAFT LINER

ID: 899

Industry: Marine
Application: SOS-Ships and Offshore Structures

Customer Location: UK Coastal Tanker operator
Application Date: March 2005

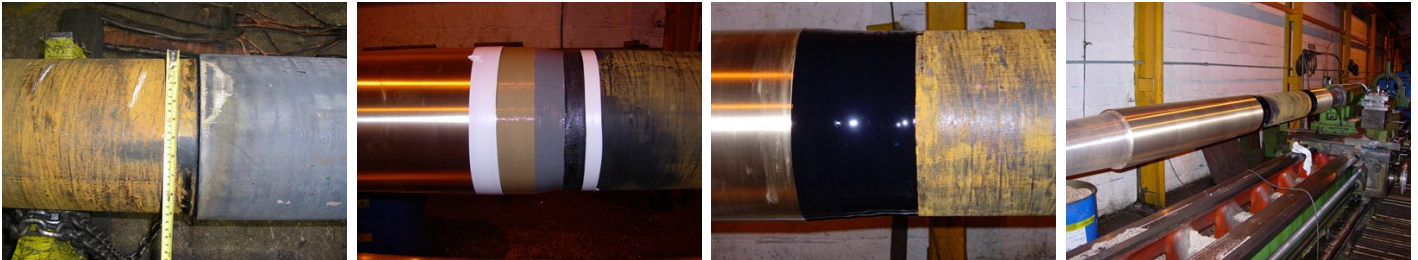
Photograph Descriptions

The bronze liners had worn and required changing. The body of the tailshaft was coated with a vulcanized rubber lining which was generally intact. Following changing of the Bronze liner the Rubber lining was damaged and not sealing. This could have lead to crevice and bi-metallic corrosion.

- * New liner fitted to shaft ,
- * Preparation and conditioning complete ,
- * Belzona® 2141 completed application ,
- * Tailshaft complete – all works were undertaken on the lathe ,

The rubber lining was cut clean away, and roughened using the Belzona Roughing brush. The Bronze liner was tapered to meet the rubber, and left with a rough thread and rebate groove. Following gritblasting of the shaft, Belzona® 1111 was applied between the liner and lining. After Conditioning, Belzona® 2141 was applied to seal between the rubber and the bronze.
