Belzona Repairs a Conveyor Belt for a Robotised Pharmaceutical Depot

ID: 8992

Application: *SHM-Solids Handling Machinery*

Application Date: *February 2023*

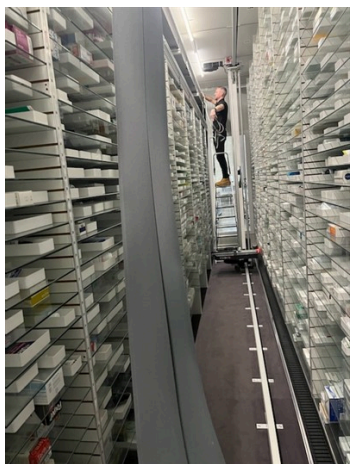
The conveyor belt had ripped at the centre all along the belt (37m) except for 4m.

The conveyor belt being removed from service.

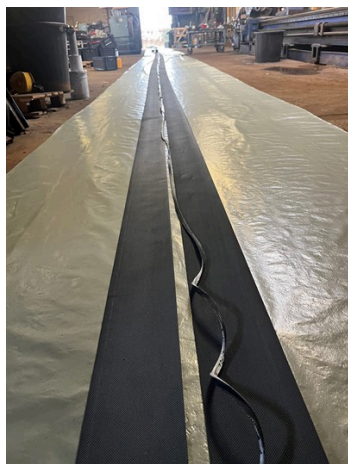
The conveyor belt mid-preparation.

The conveyor belt was prepared by cutting out the damaged rip in order to ensure a clean application. A reinforcement sheet (Belzona 9341) was used in conjunction with a multipurpose liquid elastomer (Belzona 2221). The application was carried out in accordance with a modified version of Belzona System Leaflet SHM-01.

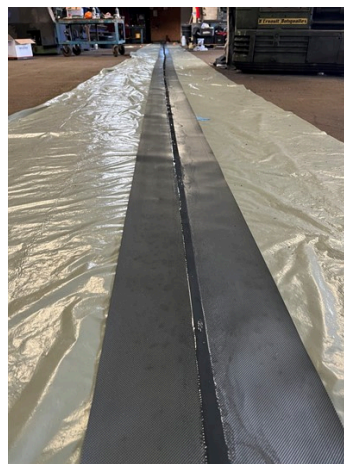
The finished and repaired conveyor belt.

The approved Belzona Distributor, conducted this repair and was able to put the conveyor belt back in service in less than 24-hours.
