# Chemical floor drains

Application: FPA-Floor Problem Areas

Products: Belzona 4181 (AHR Magma-Quartz), Belzona 4331 (Magma CR3)

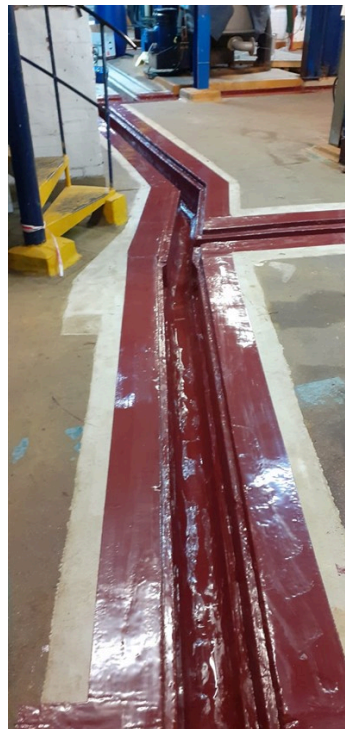
Completed 4181 concrete repairs and 4331 coating

Mix and apply the first coat of Belzona® 4331.

Once dust free and taped up a second coat of Belzona® 4331 will be applied completing this system.

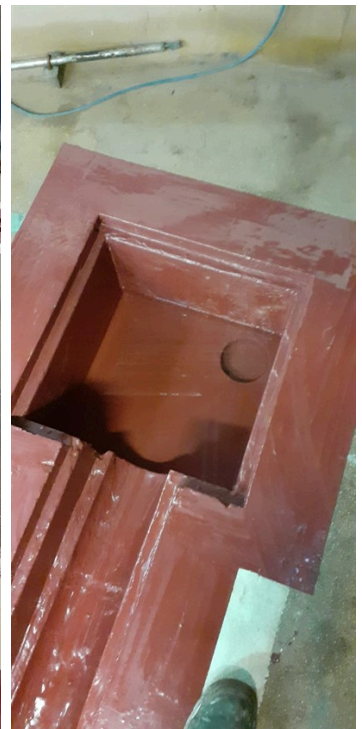
Completed 4181 concrete repairs and 4331 coating
