Chemical floor drains

ID: 8994

Application: FPA-Floor Problem Areas

Products: Belzona 4181 (AHR Magma-Quartz), Belzona 4331 (Magma CR3)

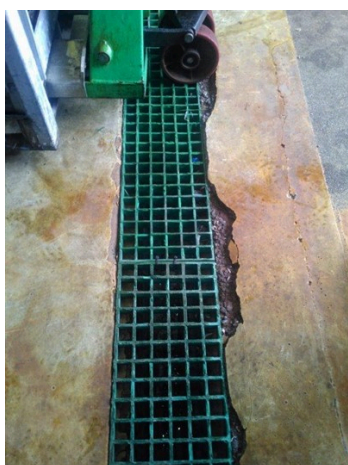
Loose grates and crack shoulders, requiring rebuilding using 4181

Carry out surface preparation to the required standard, removing surface contamination and loose concrete/repair material.

Mix and apply Belzona® 4911 surface conditioner to areas within drain channel for repair.

Mix and apply Belzona® 4181 to drain channel profile. This will be done by trowel but may also be aided with form work.

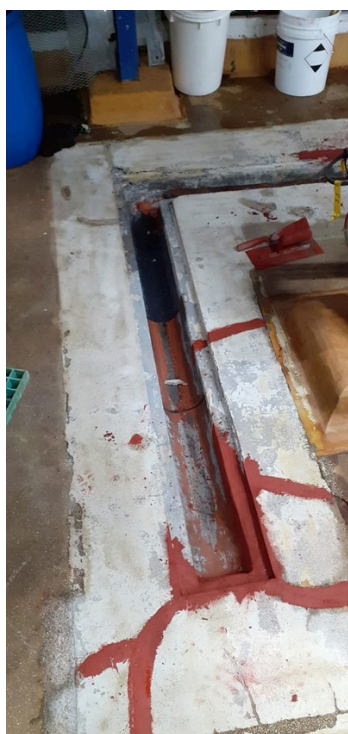
Work ongoing

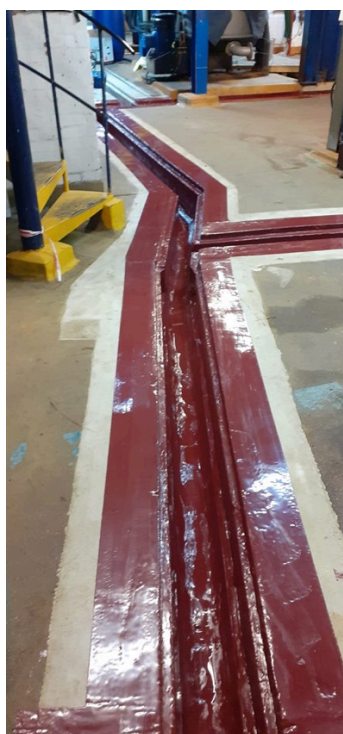
Completed 4181 concrete repairs and 4331 coating

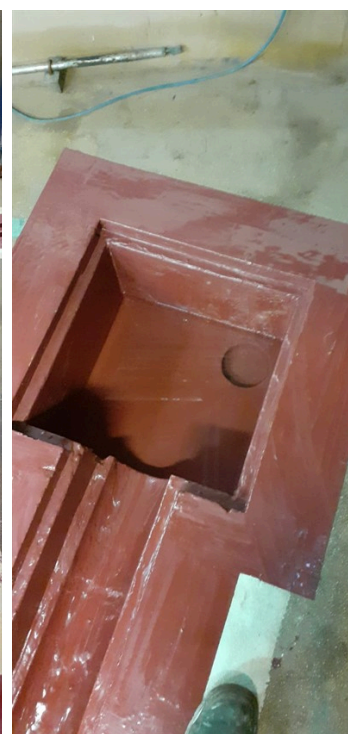
Completed 4181 concrete repairs and 4331 coating
