BELZONA PROTECTS FAST FERRY BOW THRUSTERS FROM CAVITATION

ID: 900

Industry: *Marine*
 Application: *SOS-Ships and Offshore Structures*

Customer Location: *Scandinavian Fast Ferry operator*
 Application Date: *January 2002*

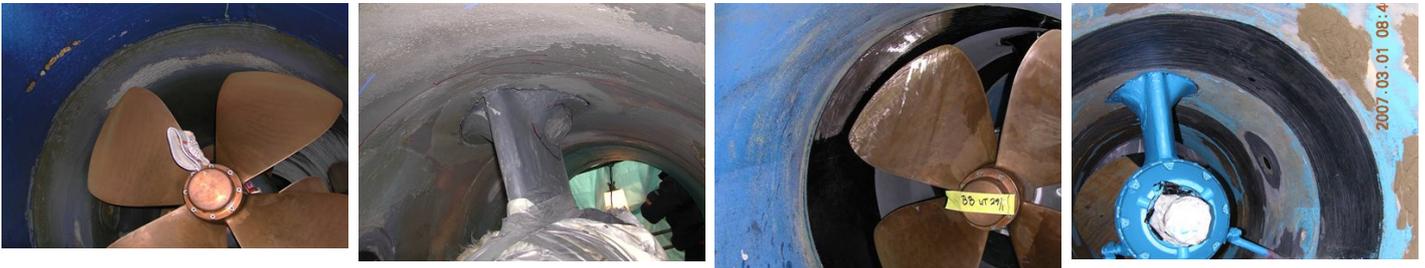
Photograph Descriptions

Cavitation problems had manifested themselves in the Port and Starboard Bow Thruster Tunnels. Annual repairs had been attempted with glass flake coatings and Belzona® 1341, but none had been ideal allowing metal loss to continue in the tunnel.

* Localized damage to Belzona® 1341 (Port) Extensive damage to Glass Flake lining (Starboard) Belzona® 2141 (Portside)
 Inspection after 5 years service ,

Following removal of the existing coatings Belzona® 2141 was applied in accordance with a modified version of SOS-1 and SOS-2.

Subsequent annual inspections have shown the Belzona® 2141 to provide outstanding cavitation protection. After nine (9) years in service the Belzona 2141 remains in excellent condition apart from a few mm² of mechanical damage. The client is extremely pleased with the application which has allowed them to extend the annual docking cycle to a bi-annual one
