Belzona Lining for Internal Protection of Hydrocyclone Tank

ID: 9005

Industry: Oil & Gas
Application: TCC-Tanks and Chemical Containment Areas
Substrate: Carbon steel
Products: Belzona 1391 (Ceramic HT)

Customer Location: Doha, Qatar
Application Date: February 2023

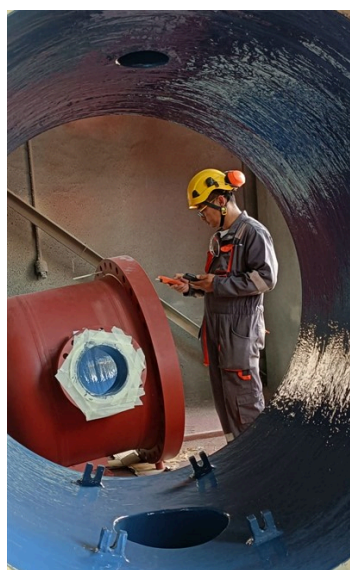
Overall internal surfaces coated with Belzona 1391.

Prior to coating application, the surface of the vessel was blasted to Sa 2.5 Near White Metal and all parameters were tested to ensure that the surface was suitable to be coated. The application of Belzona 1391 to the vessel was carried out manually at an average thickness of 500 microns, following the guidelines described in the Belzona 1391 Instructions for Use.

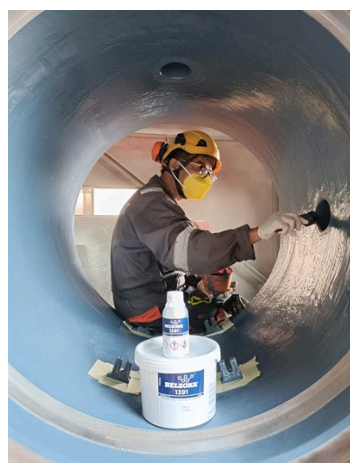
Belzona 1391 brush applied in a nozzle.

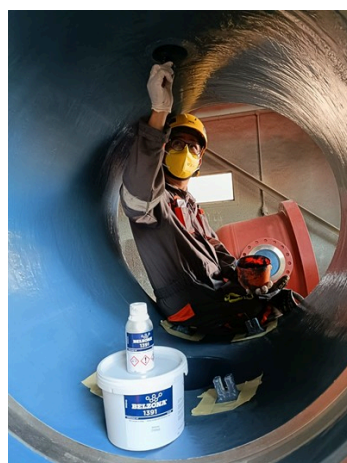
Belzona 1391 brush applied in a nozzle.

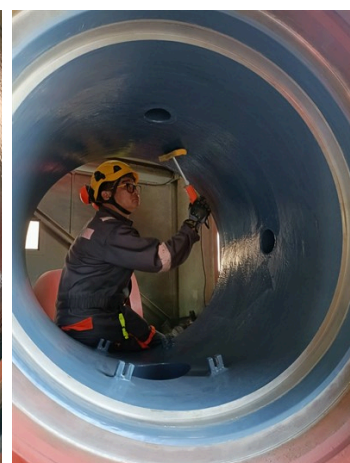
Inspection with a wet sponge tester for holiday detection.
