# Belzona Lining for Internal Protection of Hydrocyclone Tank

ID: 9005

Industry: Oil & Gas  
Application: TCC-Tanks and Chemical Containment Areas  
Substrate: Carbon steel  
Products: Belzona 1391 (Ceramic HT)

Customer Location: Doha, Qatar  
Application Date: February 2023

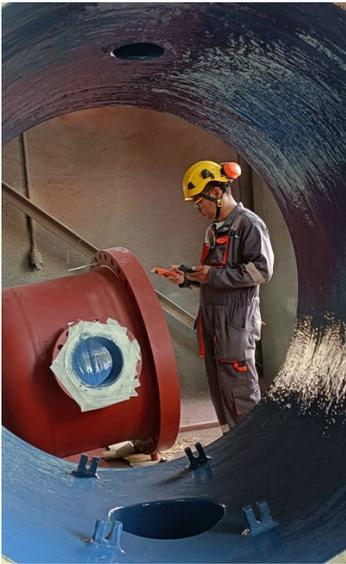
Overall internal surfaces coated with Belzona 1391.

Prior to coating application, the surface of the vessel was blasted to Sa 2.5 Near White Metal and all parameters were tested to ensure that the surface was suitable to be coated. The application of Belzona 1391 to the vessel was carried out manually at an average thickness of 500 microns, following the guidelines described in the Belzona 1391 Instructions for Use.

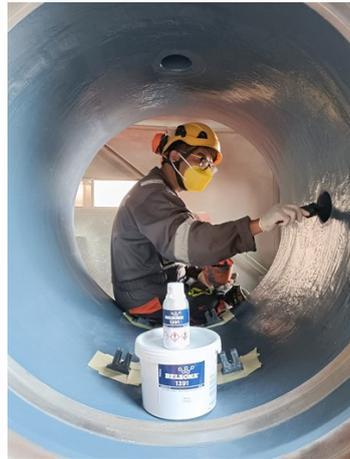
Belzona 1391 brush applied in a nozzle.

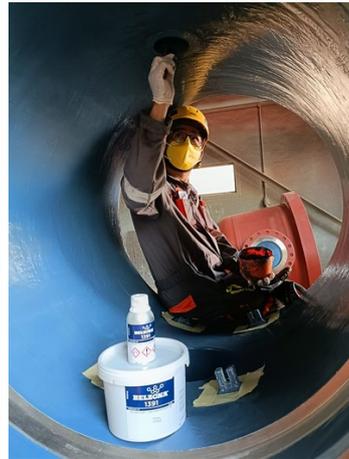
Belzona 1391 brush applied in a nozzle.

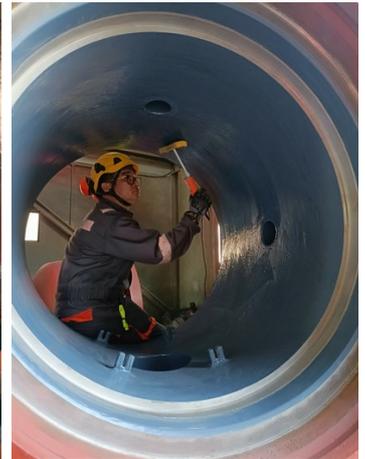
Inspection with a wet sponge tester for holiday detection.
