Rubber Lining on Limestone Filter Tank Replaced with Belzona's Epoxy Lining

ID: 9006

Industry: Power
Application: TCC-Tanks and Chemical Containment Areas
Substrate: Carbon steel
Products: Belzona 1111 (Super Metal), Belzona 1321 (Ceramic S-Metal)

Customer Location: Ras Laffan, Doha, Qatar
Application Date: June 2016

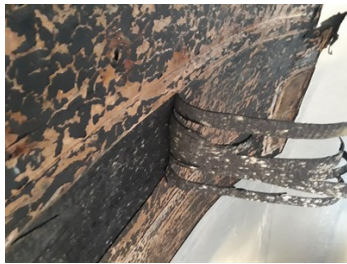
Cracks, blisters, delaminations and alligatoring were found in the existing rubber lining of the tank after a long period of use without maintenance.

Delaminations on the original rubber lining

Damaged areas of the existing rubber lining were removed and the exposed metal surface was grit blasted. Exposed deeply pitted areas were filled with Belzona 1111 and rebuilt up to 1 mm to compensate for metal loss. Multiple coats of Belzona 1321 were applied by brush for extra protection.

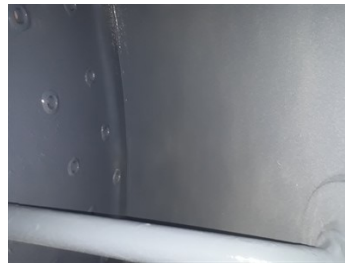
Initial coat of Belzona 1321 being applied

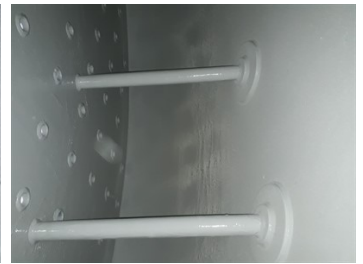
Application completed and protected tank inner surfaces
