# Rubber Lining on Limestone Filter Tank Replaced with Belzona's Epoxy Lining

Industry: Power

Customer Location: Ras Laffan, Doha, Qatar

Application: TCC-Tanks and Chemical Containment Areas

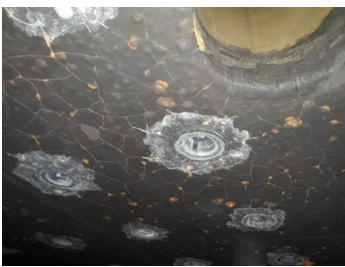
Cracks, blisters, delaminations and alligating were found in the existing rubber lining of the tank after a long period of use without maintenance.

Cracking on the original rubber lining

Damaged areas of the existing rubber lining were removed and the exposed metal surface was grit blasted. Exposed deeply pitted areas were filled with Belzona 1111 and rebuilt up to 1 mm to compensate for metal loss. Multiple coats of Belzona 1321 were applied by brush for extra protection.

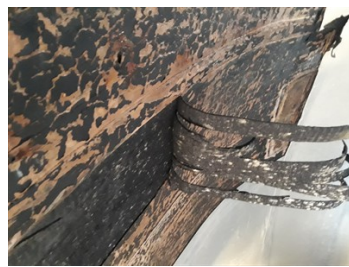
Delaminations on the original rubber lining

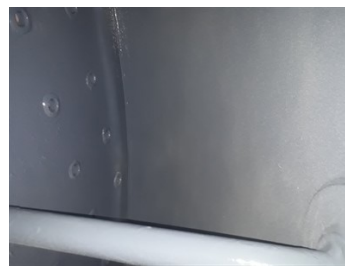
Initial coat of Belzona 1321 being applied

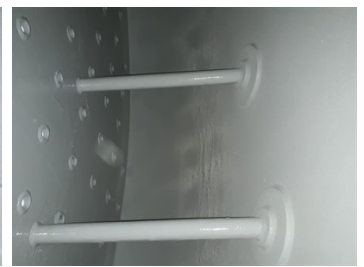
Application completed and protected tank inner surfaces
