External Coating for Airport Jet Fuel Pipeline

ID: 9008

Industry: Oil & Gas
 Application: VPF-Valves, Pipes and Fittings
 Substrate: Carbon steel
 Products: Belzona 5831 (ST-Barrier)

Customer Location: Dubai, UAE
 Application Date: December 2022

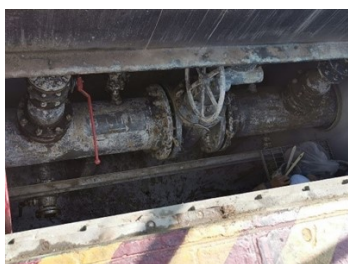
The facility manager responsible for the airport's infrastructure found problems related to the jet fuel pipeline. Corrosion has been detected, posing a significant risk to the safety and reliability of the pipeline.

Original condition of the corroded pipeline

The application was carried out in accordance with Belzona Know-How System Leaflet VPF-2 and two coats of Belzona 5831 was applied. As hot work was prohibited, manual surface preparation was carried out. No damage was caused by this process.

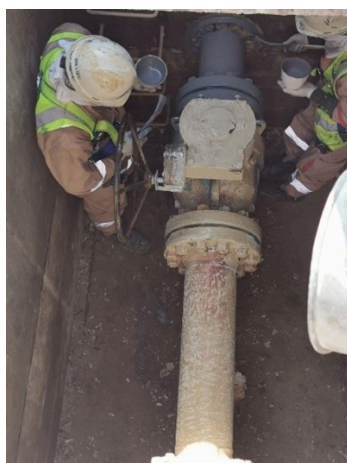
Application in progress

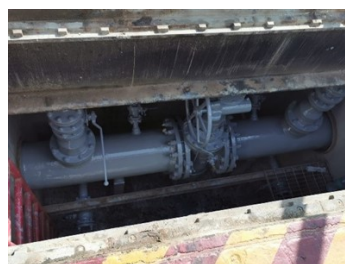
Application completed

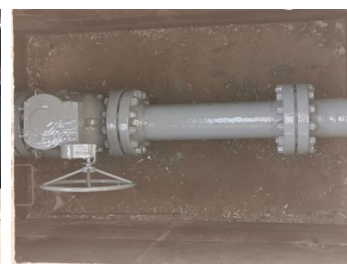
Pipeline fully coated for corrosion protection
