External Coating for Airport Jet Fuel Pipeline

ID: 9008

Industry: Oil & Gas
 Application: VPF-Valves, Pipes and Fittings
 Substrate: Carbon steel
 Products: Belzona 5831 (ST-Barrier)

Customer Location: Dubai, UAE
 Application Date: December 2022

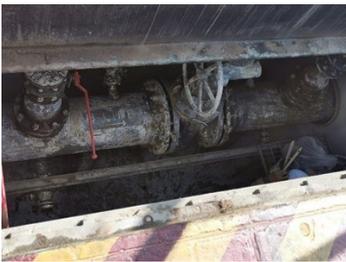
The facility manager responsible for the airport's infrastructure found problems related to the jet fuel pipeline. Corrosion has been detected, posing a significant risk to the safety and reliability of the pipeline.

Original condition of the corroded pipeline

The application was carried out in accordance with Belzona Know-How System Leaflet VPF-2 and two coats of Belzona 5831 was applied. As hot work was prohibited, manual surface preparation was carried out. No damage was caused by this process.

Belzona 5831 was chosen because it allowed minimum level of surface preparation, as there were concerns about damaging the pipe during surface preparation. Also because it can coat surfaces contaminated with oil. The asset remained operational during the application. This helped avoid expensive shutdowns and downtime just for repairs.

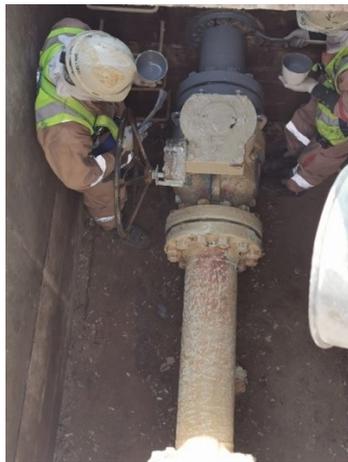
Application in progress

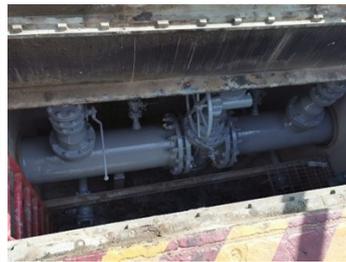
Application completed

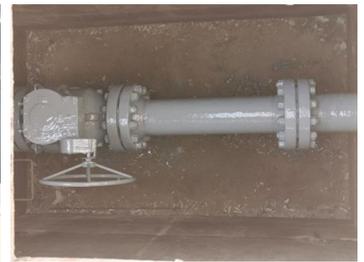
Pipeline fully coated for corrosion protection
